Technical Note N-620

AIRFIELD PAVEMENT EVALUATION - USMCAS YUMA, ARIZONA

U. S. NAVAL CIVIL ENGINEERING LABORATORY
Port Hueneme, California

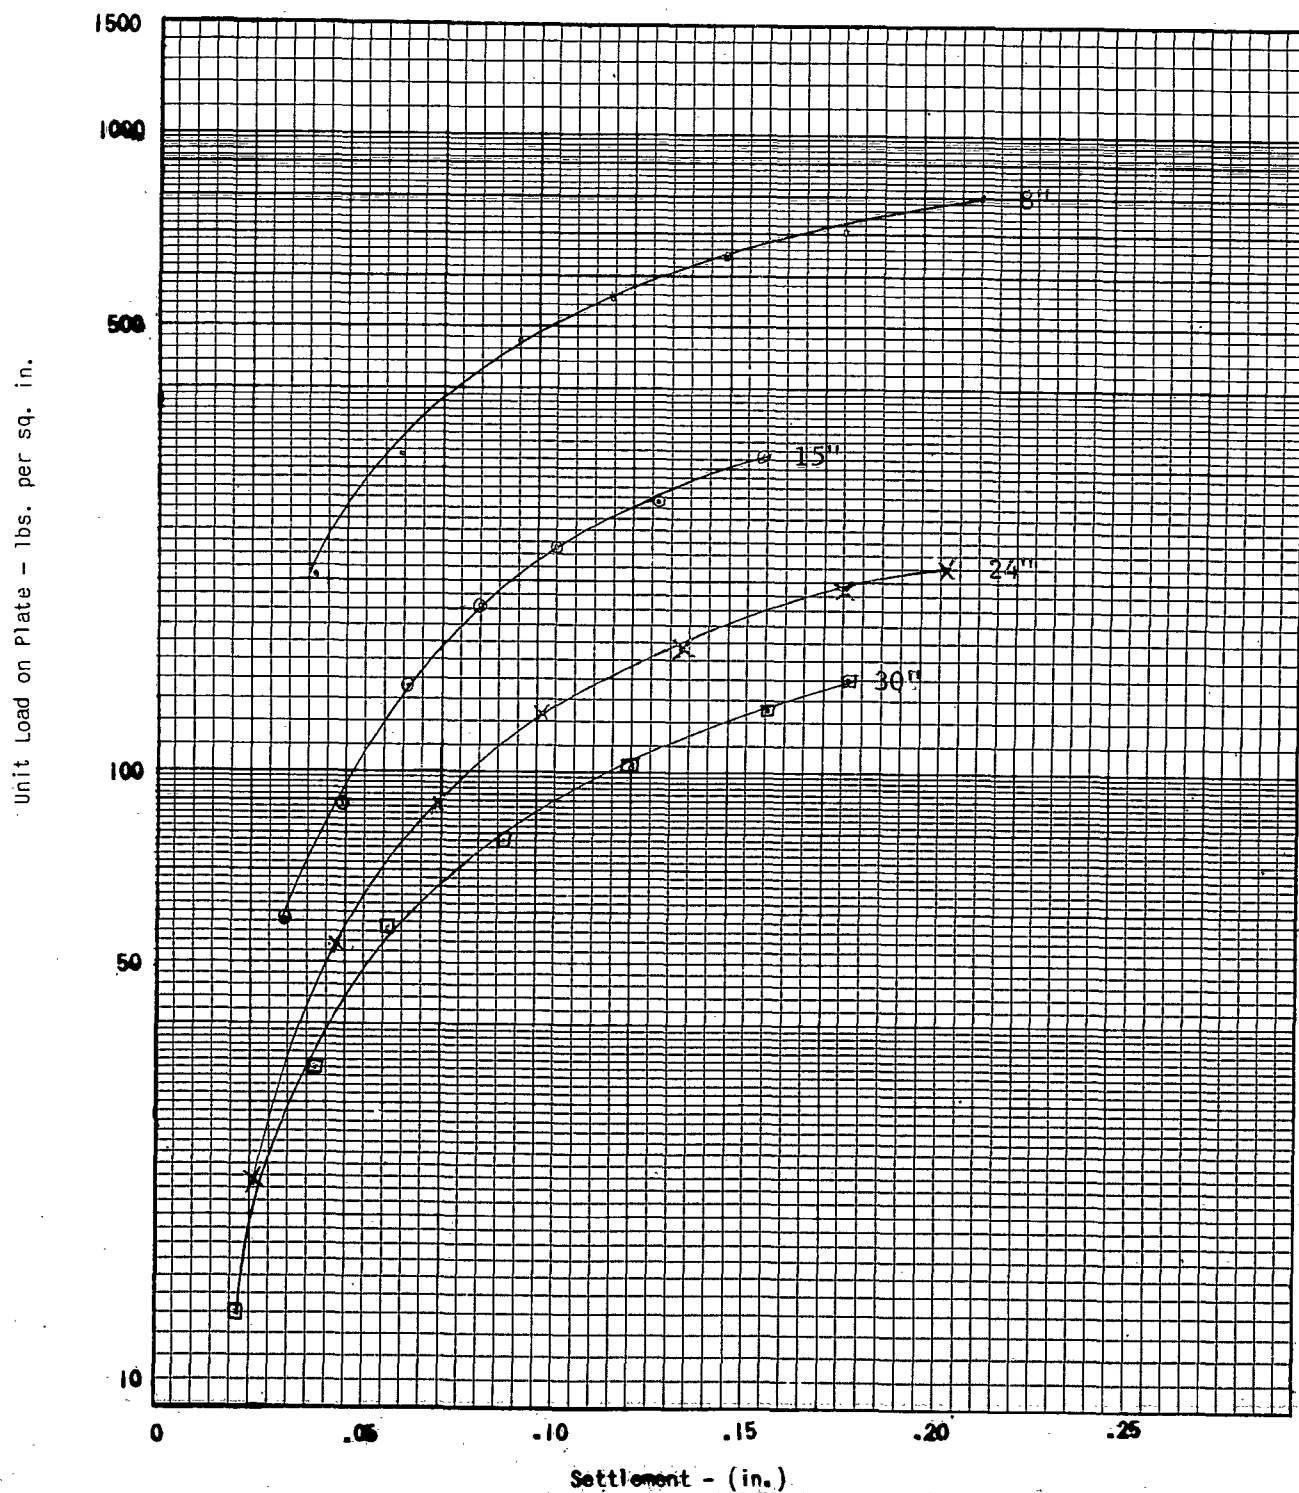
PLATE BEARING TEST DATA

Pressure vs. Deflection

FACILITY
USMCAS Yuma, ArizonaLOCATION
Runway 08-26STATION
16+00

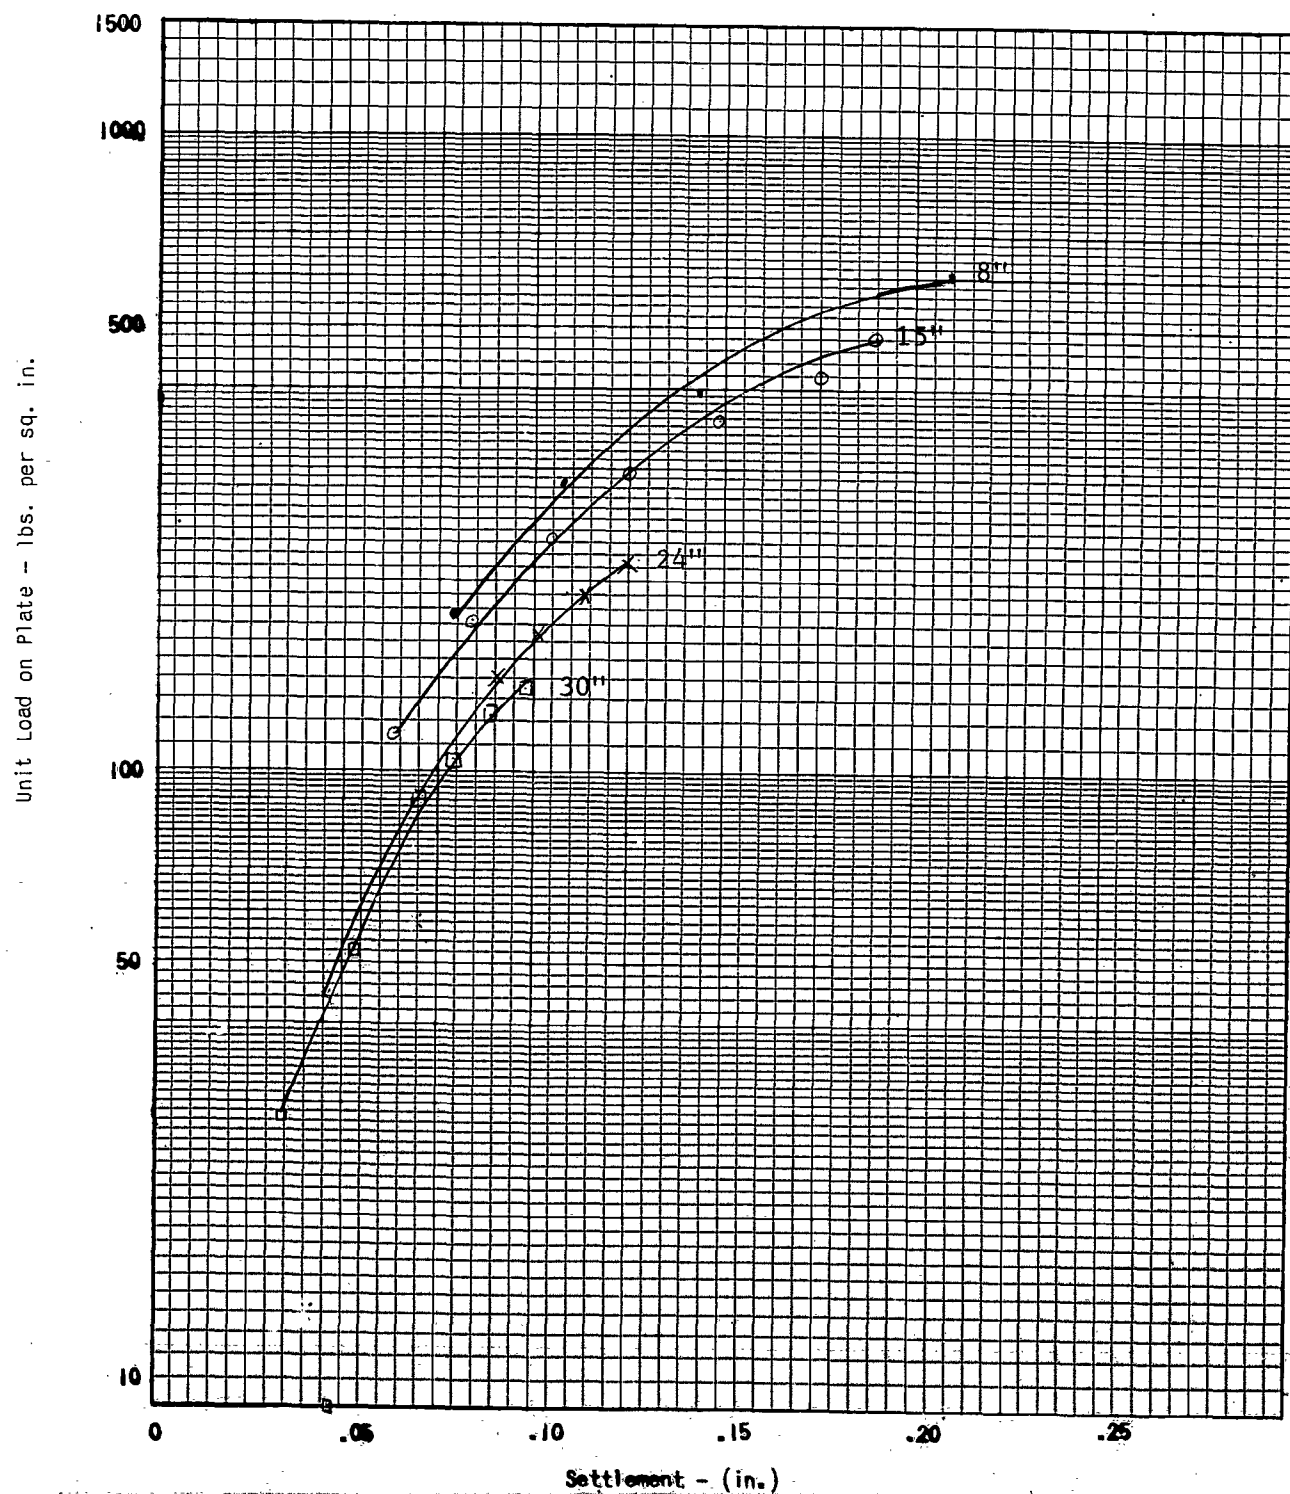
PLATE BEARING TEST DATA

Pressure vs. Deflection

FACILITY
USMCAS Yuma, ArizonaLOCATION
Taxiway 6STATION
1+50 Offset

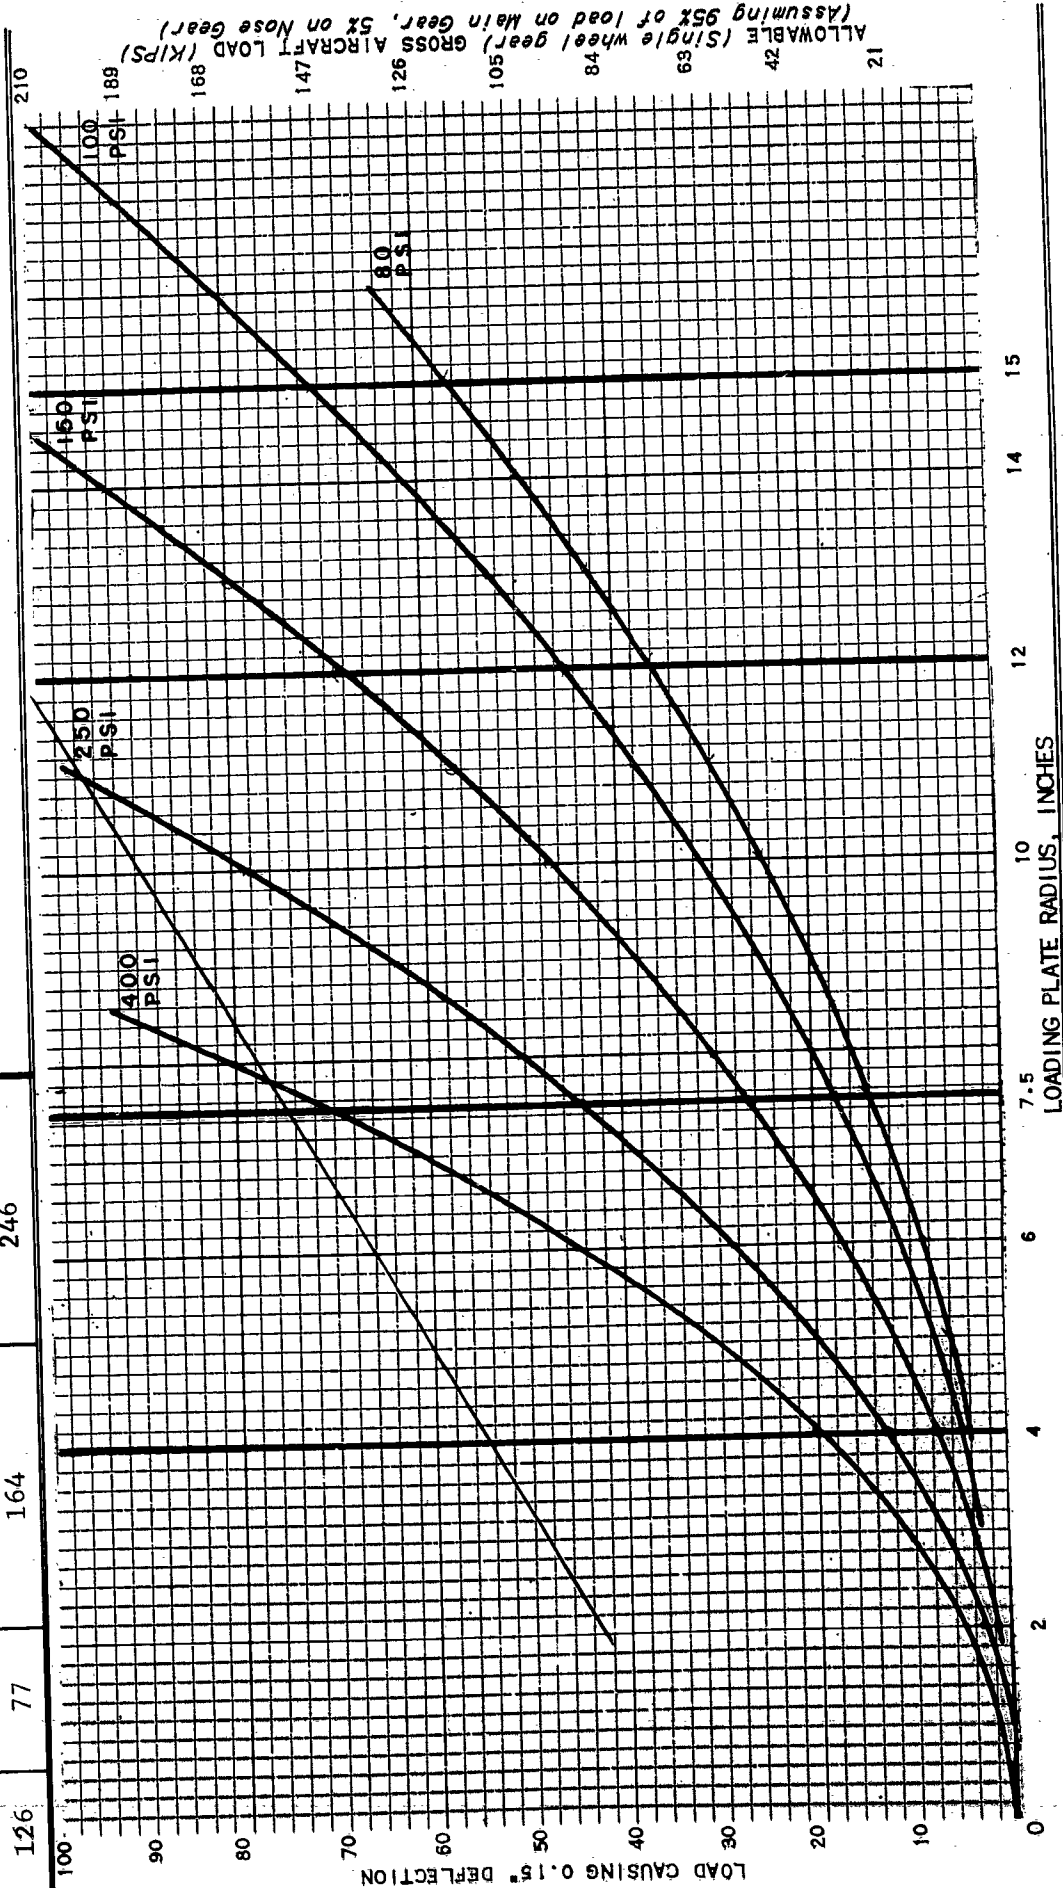
GRAPHIC METHOD FOR DETERMINING ALLOWABLE GROSS AIRCRAFT LOADS (Single Wheel Gear)

ALLOWABLE GROSS AIRCRAFT WHEEL LOADS (KIPS)		
SINGLE WHEEL GEAR	DUAL WHEEL GEAR SWG X 1.30	DUAL TANDEM GEAR SWG X 1.95
150 PSI TIRES	400 PSI TIRES	150 PSI
126	77	246
	164

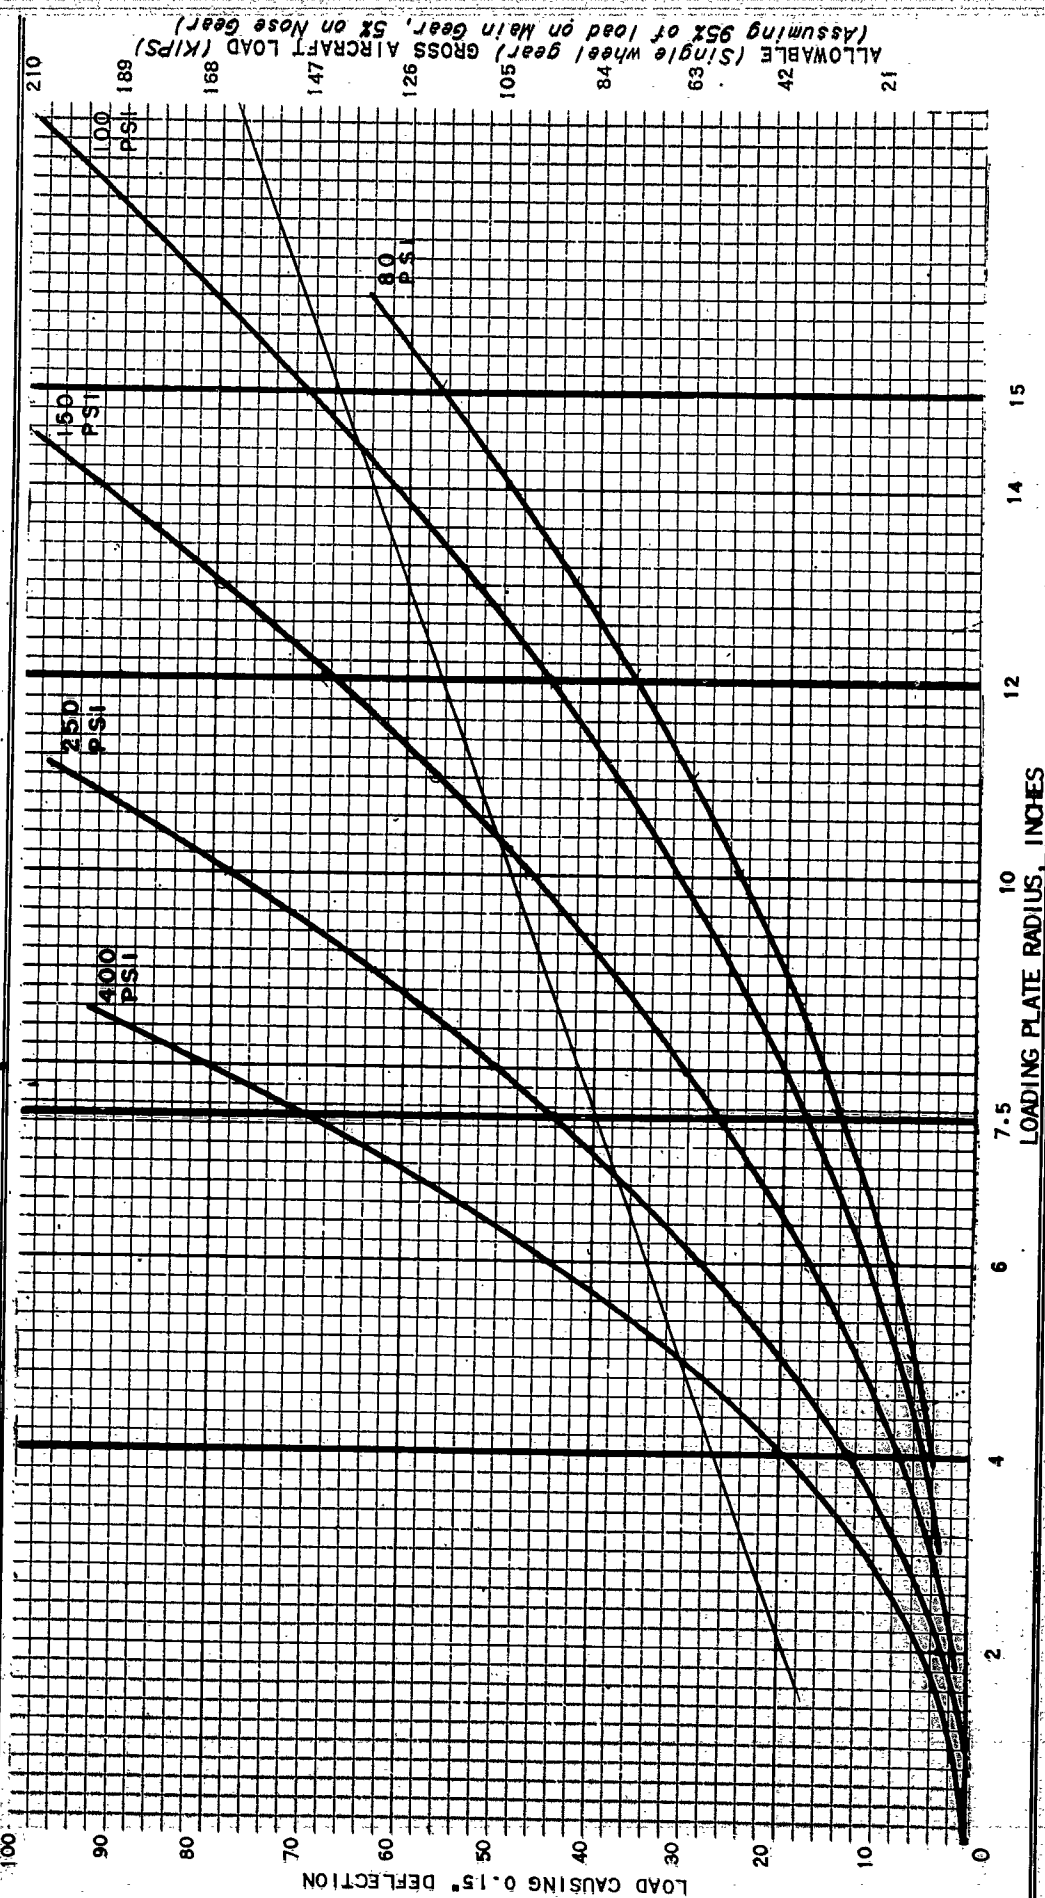
FACILITY		US MCAS Yuma, Arizona		LOCATION	Runway 8-26	DATE	June 1964
ALLOWABLE GROSS AIRCRAFT WHEEL LOADS (KIPS)				GRAPHIC METHOD FOR DETERMINING ALLOWABLE GROSS AIRCRAFT LOADS (Single Wheel Gear)			
SINGLE WHEEL GEAR		DUAL WHEEL GEAR		DUAL TANDEM GEAR			
150 PSI TIRES, 400 PSI TUBES		SWG X 1.30 150 PSI		SWG X 1.95 150 PSI			
50 30		65		98
